**Race Rocks Lighthouse**  
**Great Race Island, British Columbia**  
DFRP # 17447

**Condition Assessment**  
**Including Indicative Cost Estimate**

**Date:** December 14, 2007  
**HCD Project Number:** 115365  
**Team Leader:** Ève Wertheimer

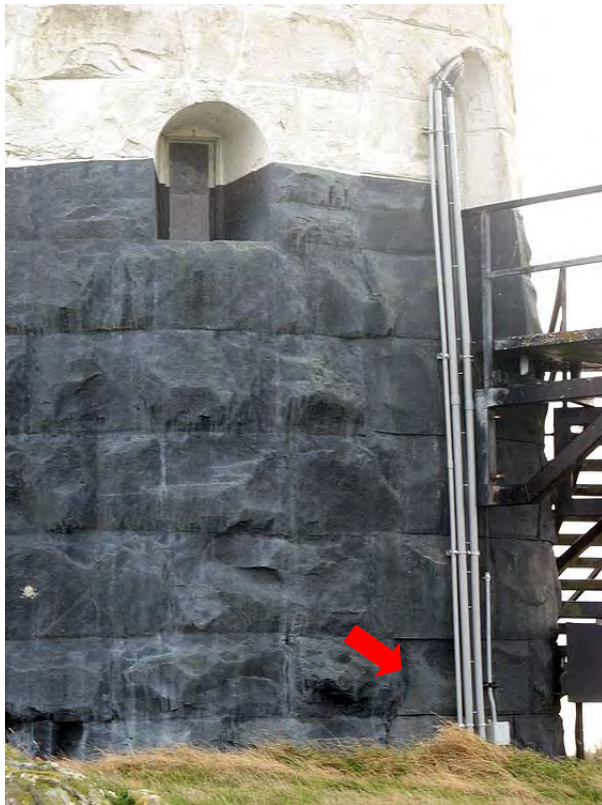
**Figure 12:** Large hammer-dressed coursings of the tower foundations, below the door opening. Note the transition from parging to natural stone right of the door opening, next to the conduits and the vertical crack along it. (HCN/2007)

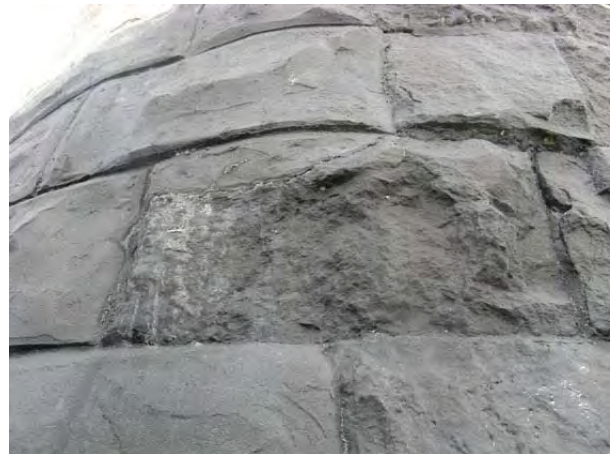
**Figure 13:** Natural stone and formed cement parging at the foundation level. (HCN/2007)

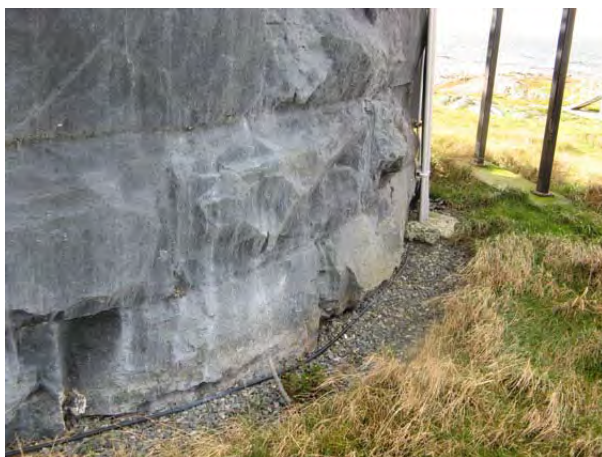
**Figure 14:** Breaks in the base course and white streaking. (HCN/2007)

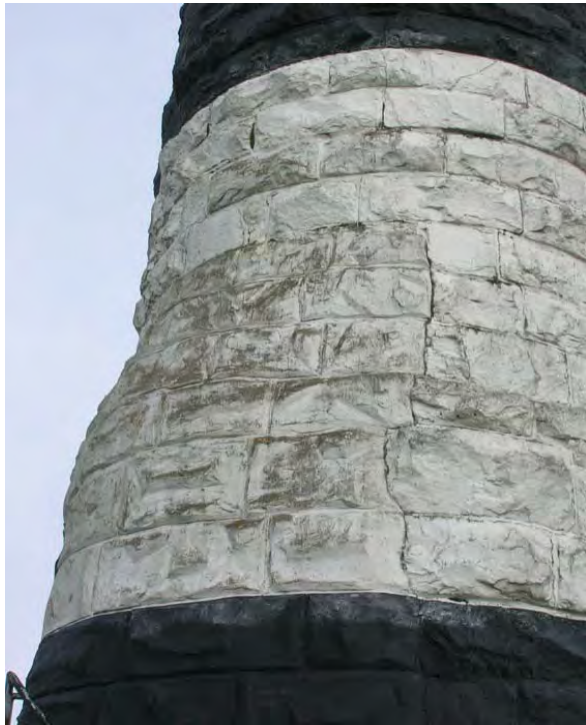
**Figure 16:** Deformed exterior tower wall at its former point of connection with the demolished residence. (HCN/2007)

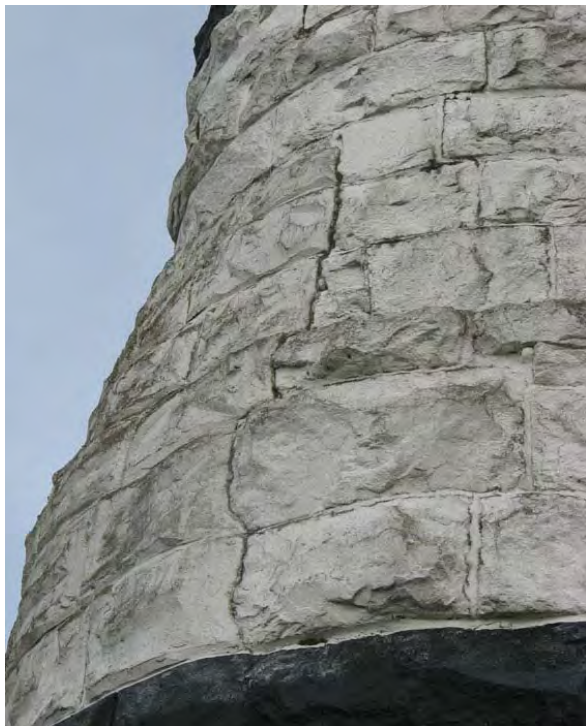
**Figure 18:** Vertical crack extending along the southwest face of the tower. (HCN/2007)

23. Regular verification of the cracks, and keeping them sealed to prevent water entry into the wall.
24. Cyclical maintenance and replacement of the parging at the base of the tower.
25. Inspection of stonework for evidence of new spalling, as well as for performance of repairs. Inspection of the masonry is to precede the application of exterior coating.
26. Cleaning of the wall surfaces, with mechanical removal of algae growths and removal of stains, mould and calcite.
27. Renewal of the impervious coating on the exterior face of the lighthouse is anticipated on a 25-year cycle. Repainting of the day marking may be required at closer intervals.

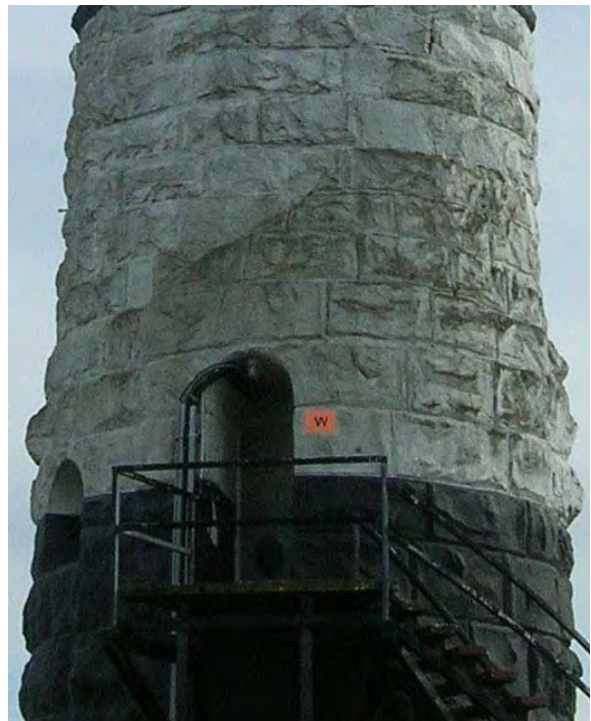
**Figure 19:** Crack prolonging diagonally above the door. (HCN/2007)

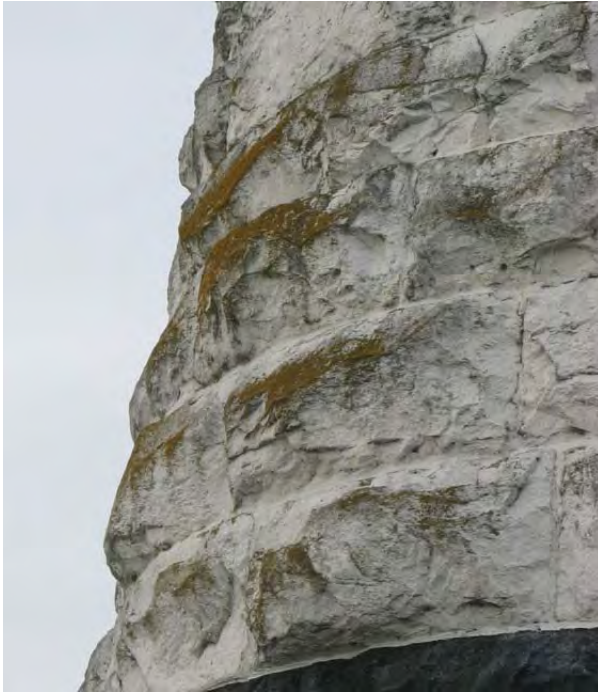
**Figure 20:** Algae growth on the south face of the tower. (HCN/2007)

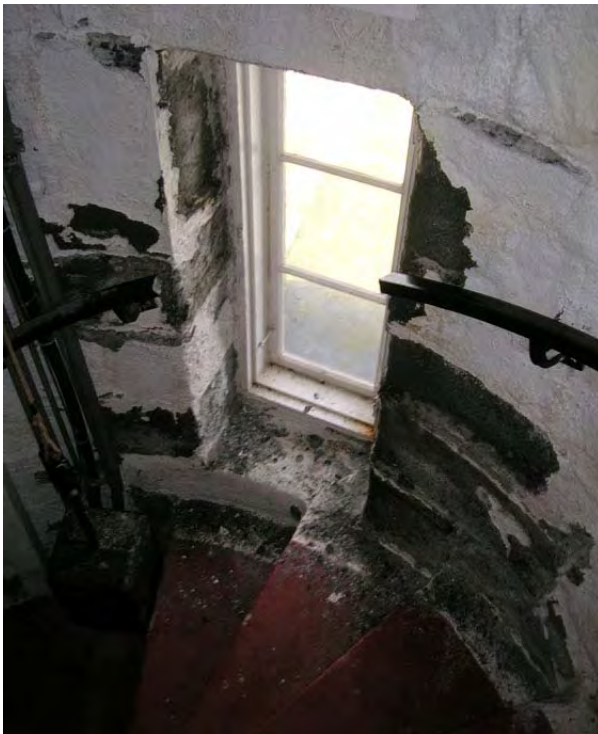
**Figure 22:** Stone deterioration around the interior of the top window opening. (HCN/2007)

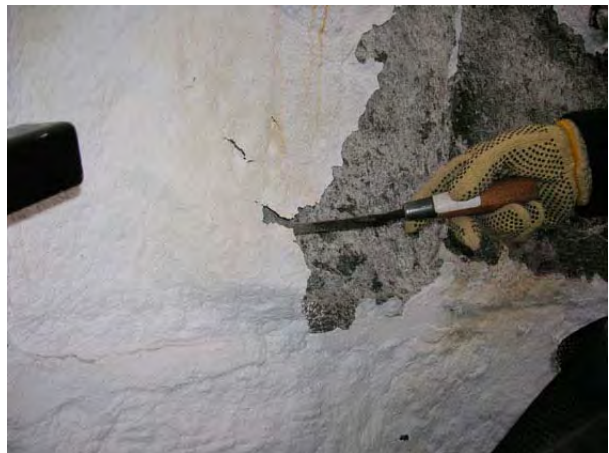
**Figure 23:** Paint failure on the interior face of the walls. (HCN/2007)

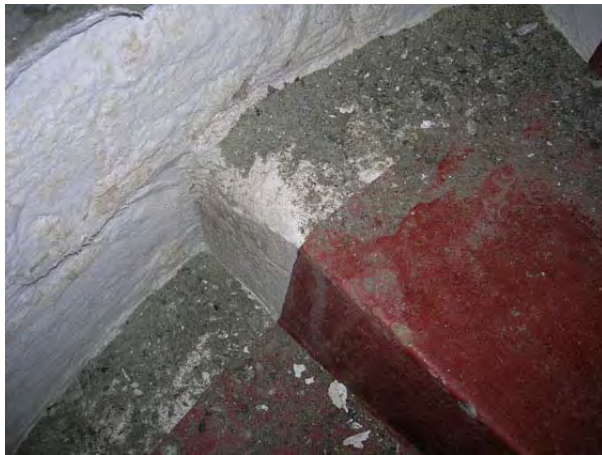
**Figure 24:** Debris accumulation on the steps. (HCN/2007)

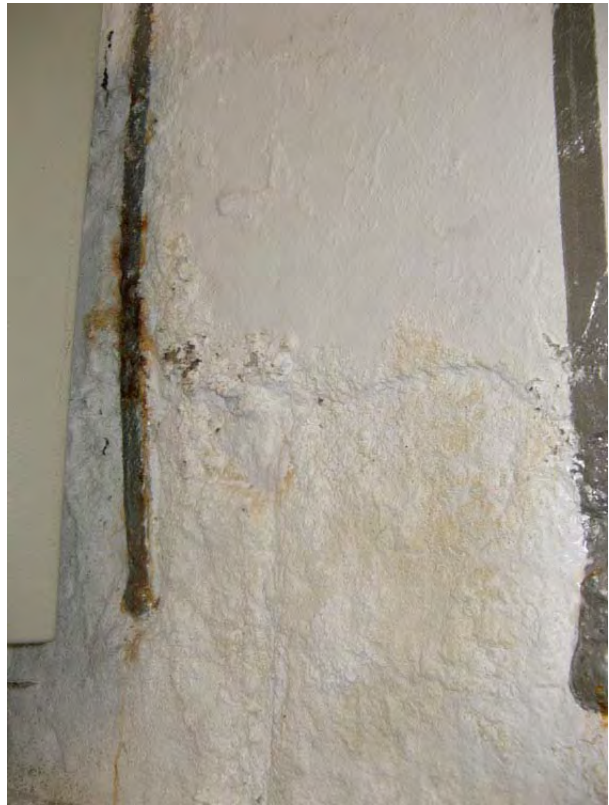
**Figure 25:** Corroded metal ties at the top of the interior walls. (HCN/2007)

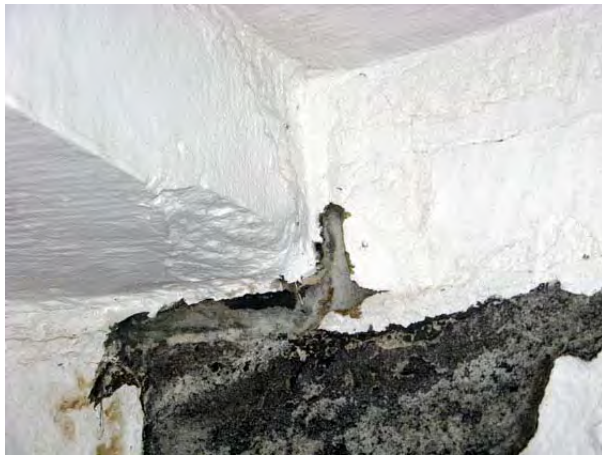
**Figure 26:** Traces of deterioration at the junction between the stone steps and the tower walls. (HCN/2007)

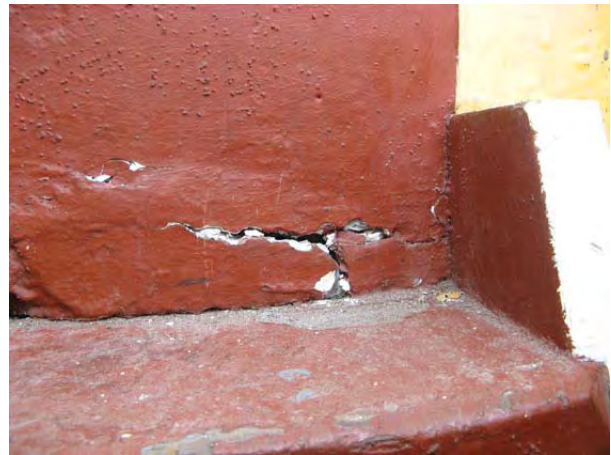
**Figure 31:** Deterioration of the concrete slab at its connection to the ladder. (HCN/2007)

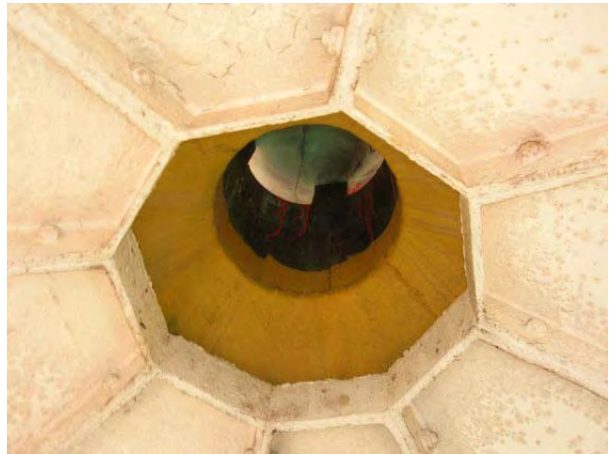
**Figure 33:** Underside of the lantern cupola and mildew stains. (HCN/2007)

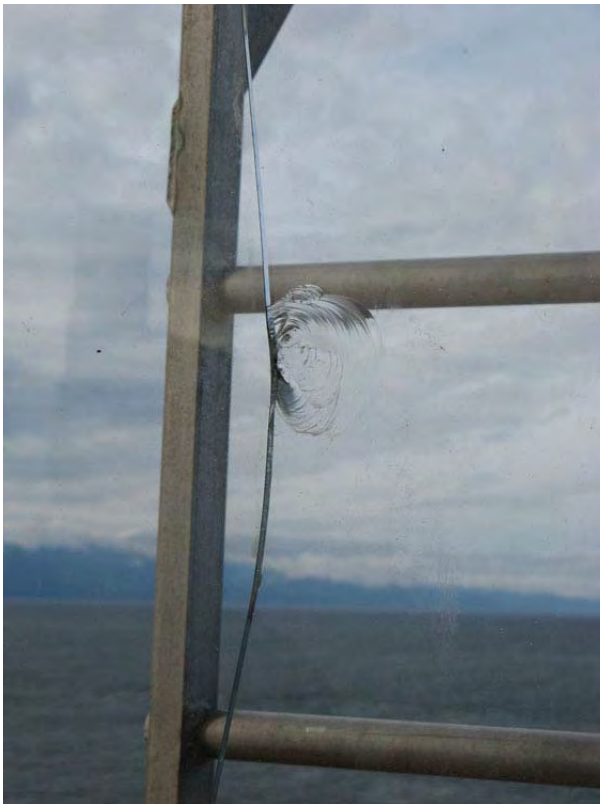
**Figure 34:** Vertical crack in the west pane of glass. (HCN/2007)

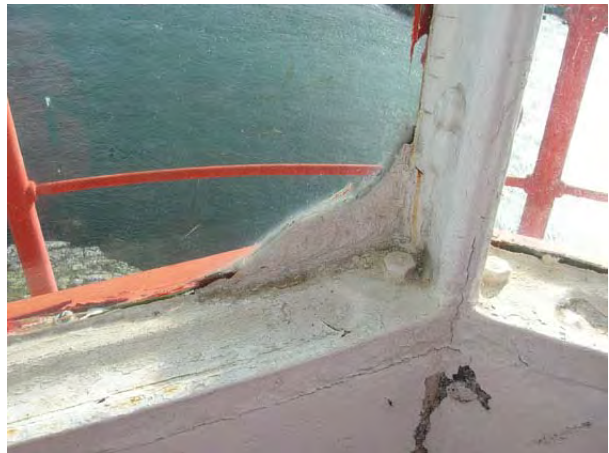
**Figure 35:** Large amount of caulking concentrated in the lower corner of a storm panel. (HCN/2007)

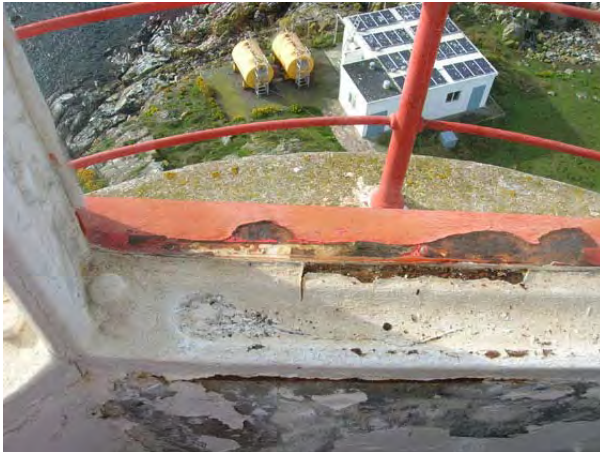
**Figure 36:** Corrosion and rotted exterior wood stops along the outer sill of a storm panel. (HCN/2007)

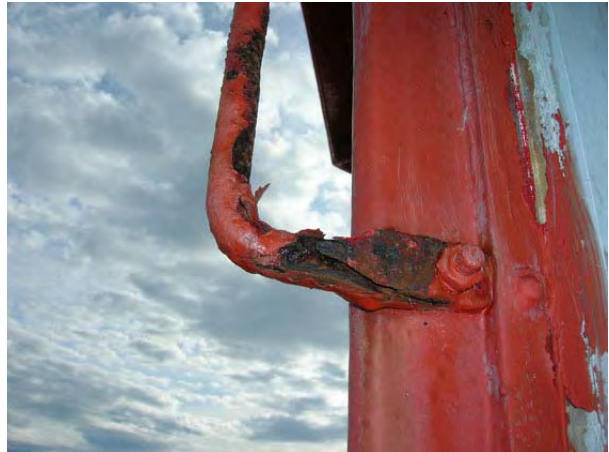
**Figure 37:** Corroded exterior hand-hold. (HCN/2007)

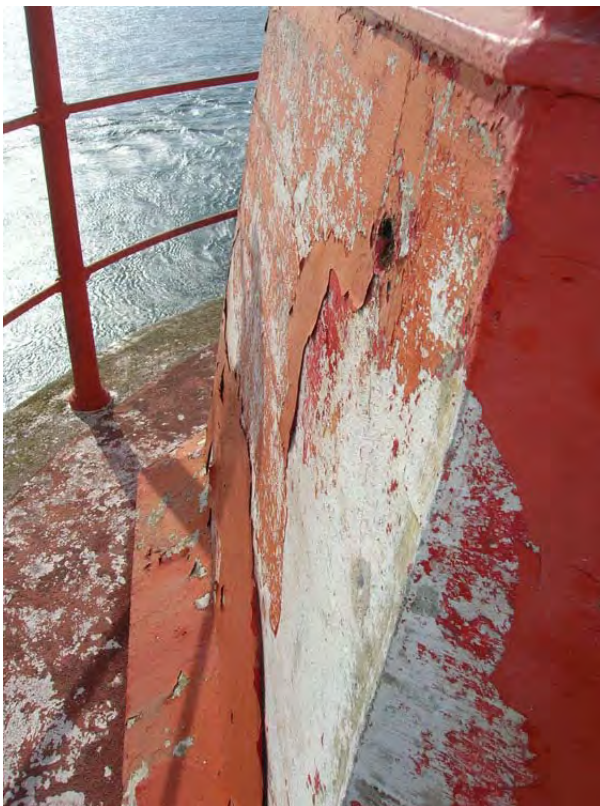
**Figure 38:** Exterior paint failure on the concrete parapet. (HCN/2007)

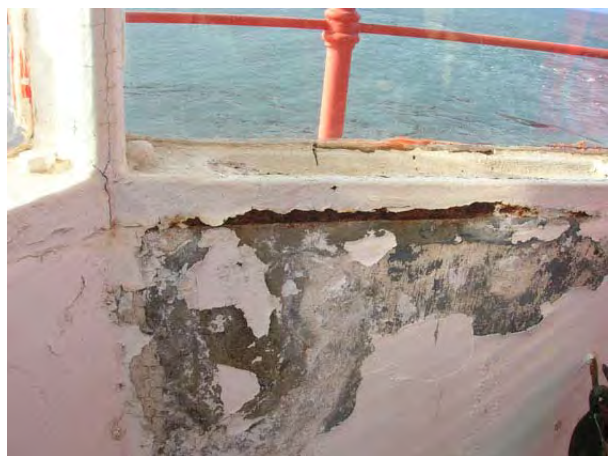
**Figure 39:** Corrosion and paint failure on the interior face of the parapet. (HCN/2007)

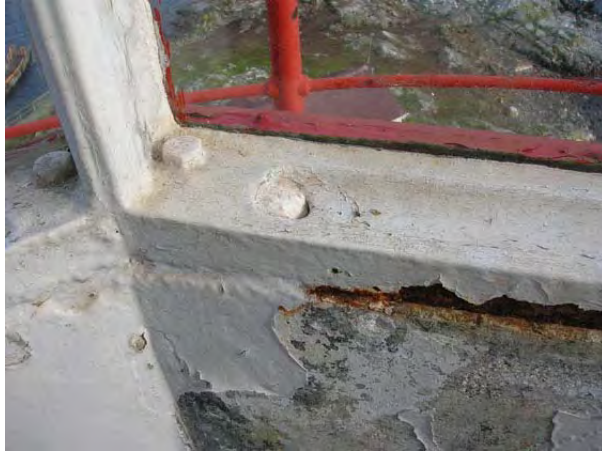
**Figure 40:** Condensation gutter and obstructed drain. (HCN/2007)

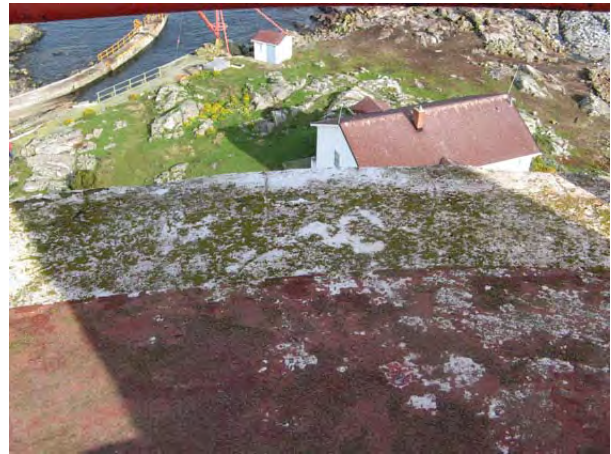
**Figure 45:** Coating failure and hairline cracks on the gallery. (HCN/2007)

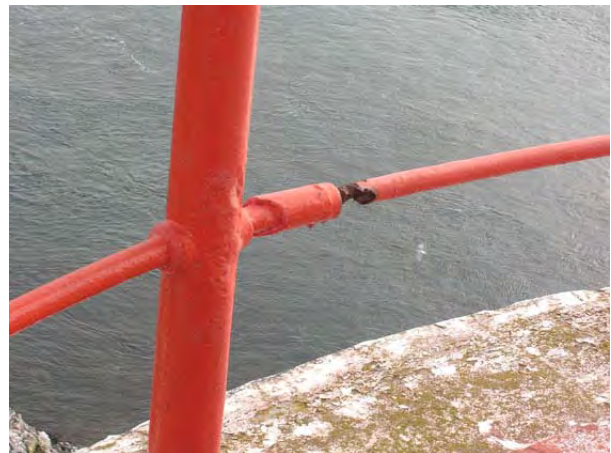
**Figure 47:** Corroded guardrail. (HCN/2007)

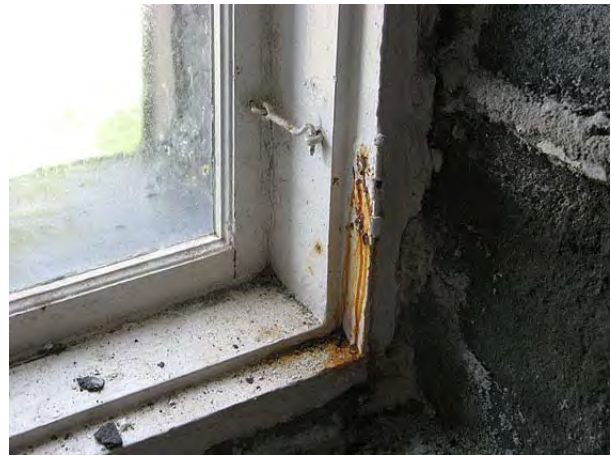
**Figure 51:** Typical deterioration of the wood sash: corroded metal hooks, staining and stone damage concentrated at the base of the opening. (HCN/2007)

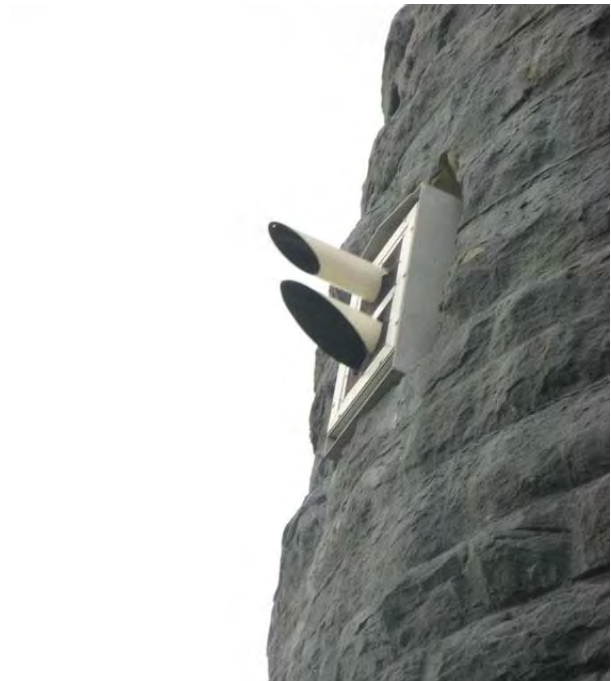
**Figure 53:** Exterior view of the fog-detector and the broken stone lintel above it. (HCN/2007)

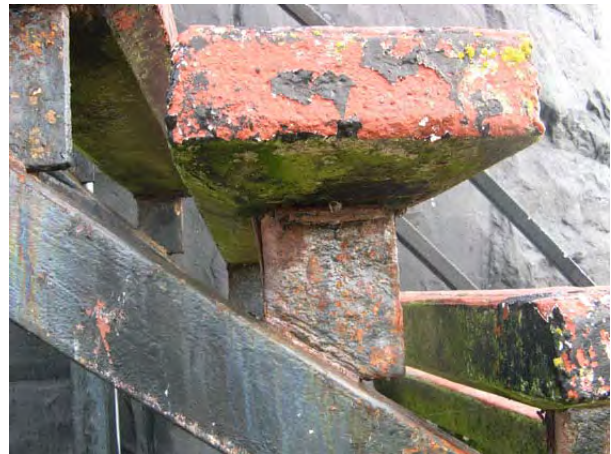
**Figure 57:** Surface corrosion on the structural members. (HCN/2007)

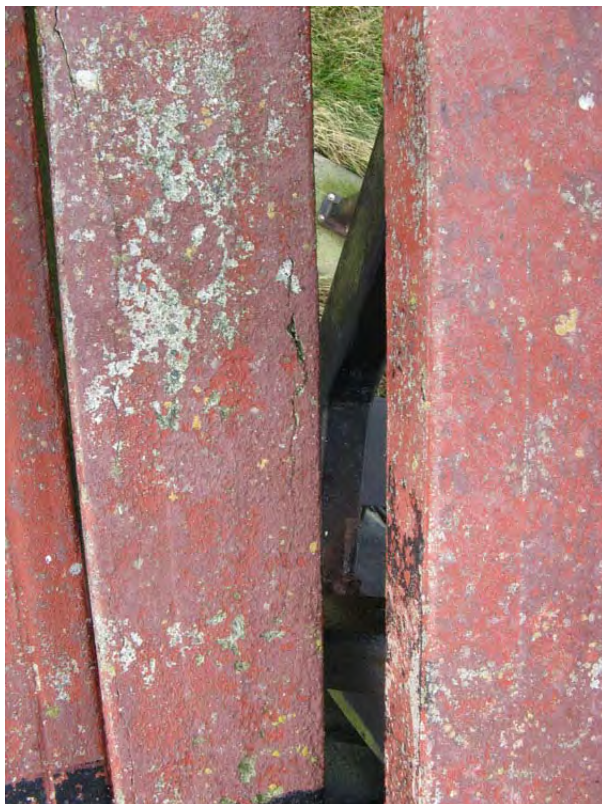
**Figure 58:** Cracked concrete treads. (HCN/2007)

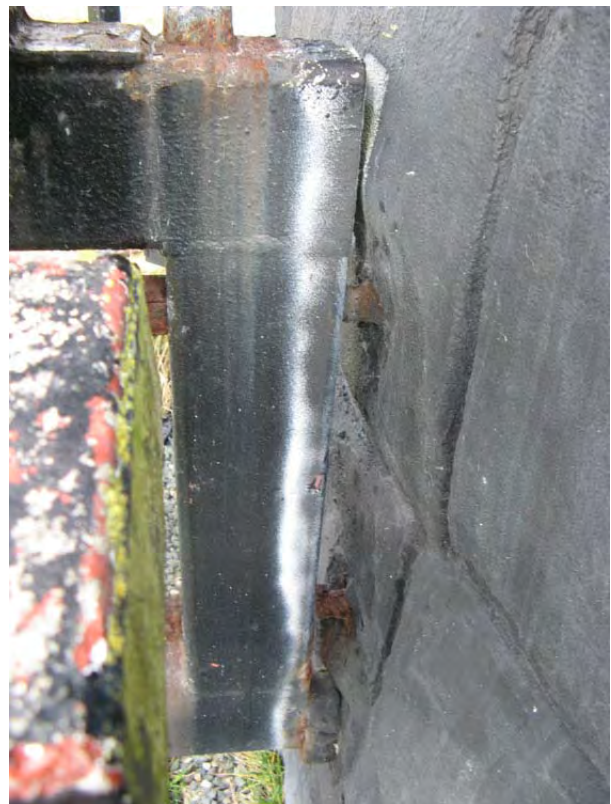
**Figure 59:** Stair brackets and corroded anchors set into the stone wall. (HCN/2007)

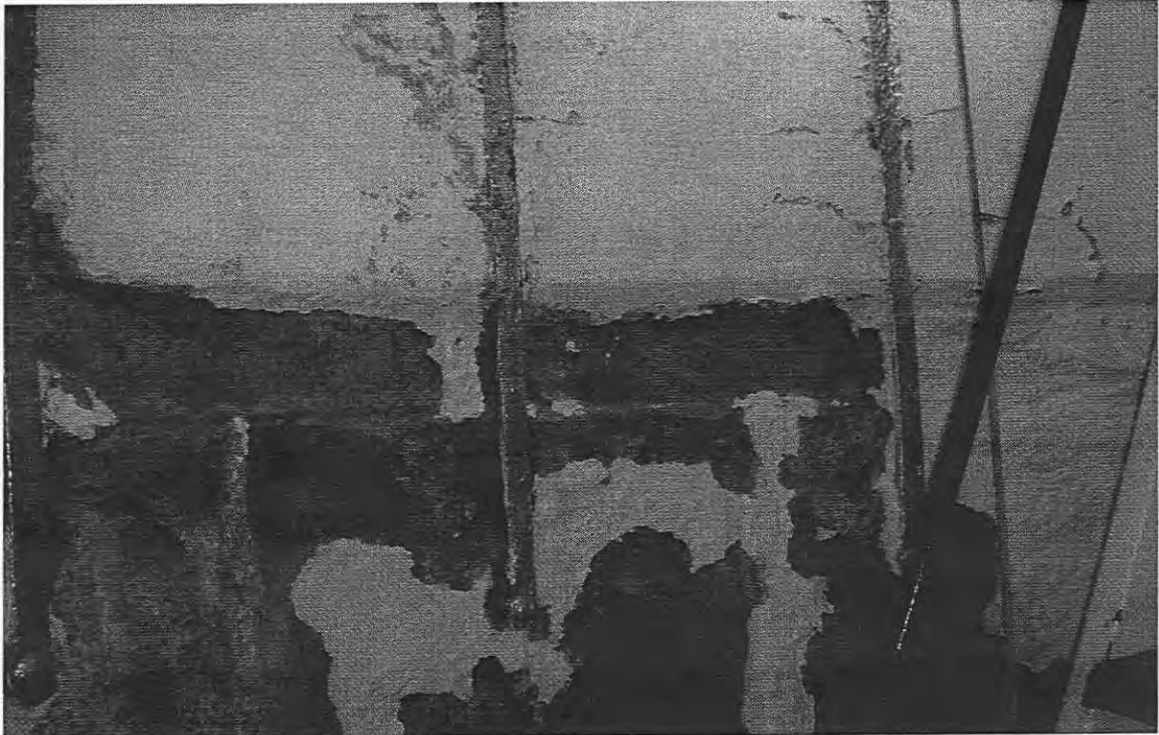
Photo 2. Scaling of Interior Sandstone.

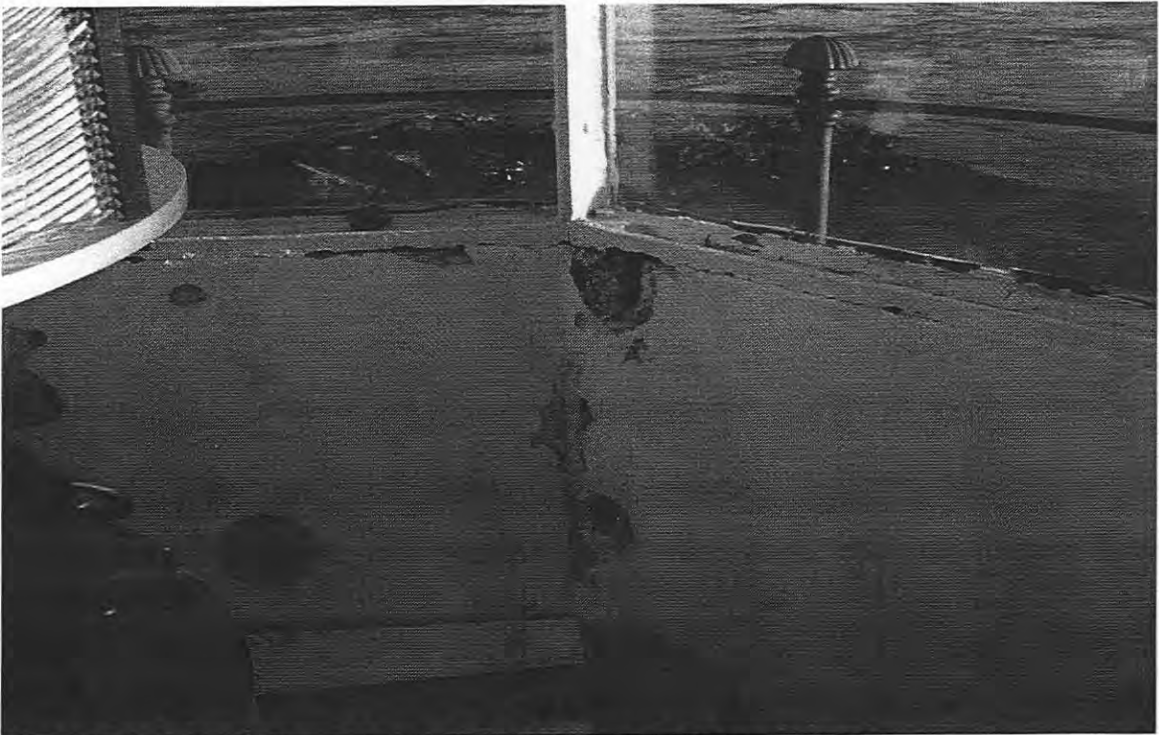
Photo 3. Interior of Lamphouse showing deteriorated concrete.

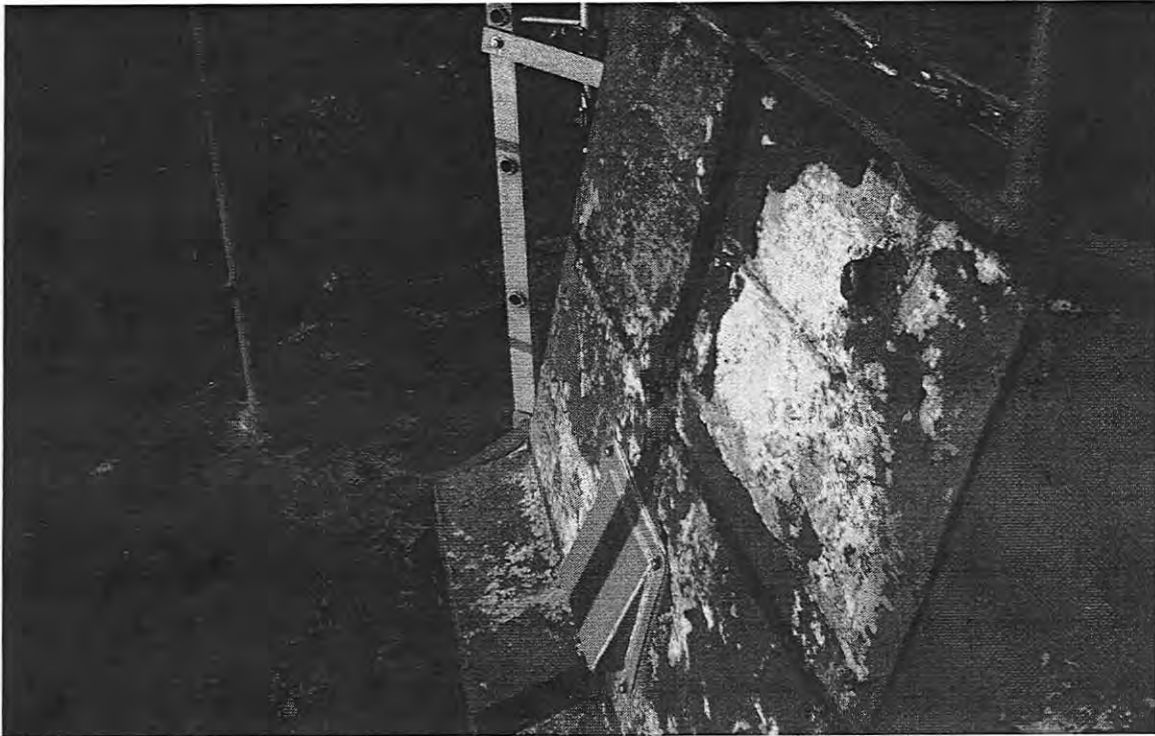
Photograph 4. Exterior of Lamphouse showing Peeling Paint.

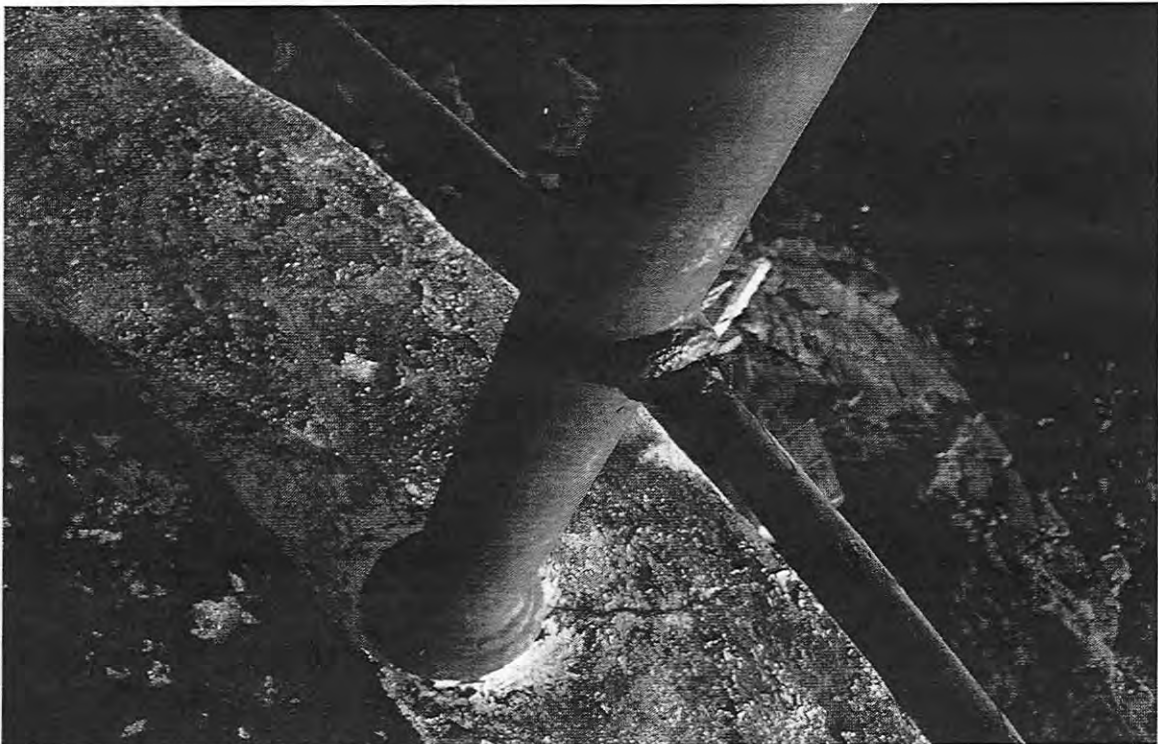
Photograph 5. Deck of Lamphouse showing Peeling Membrane.

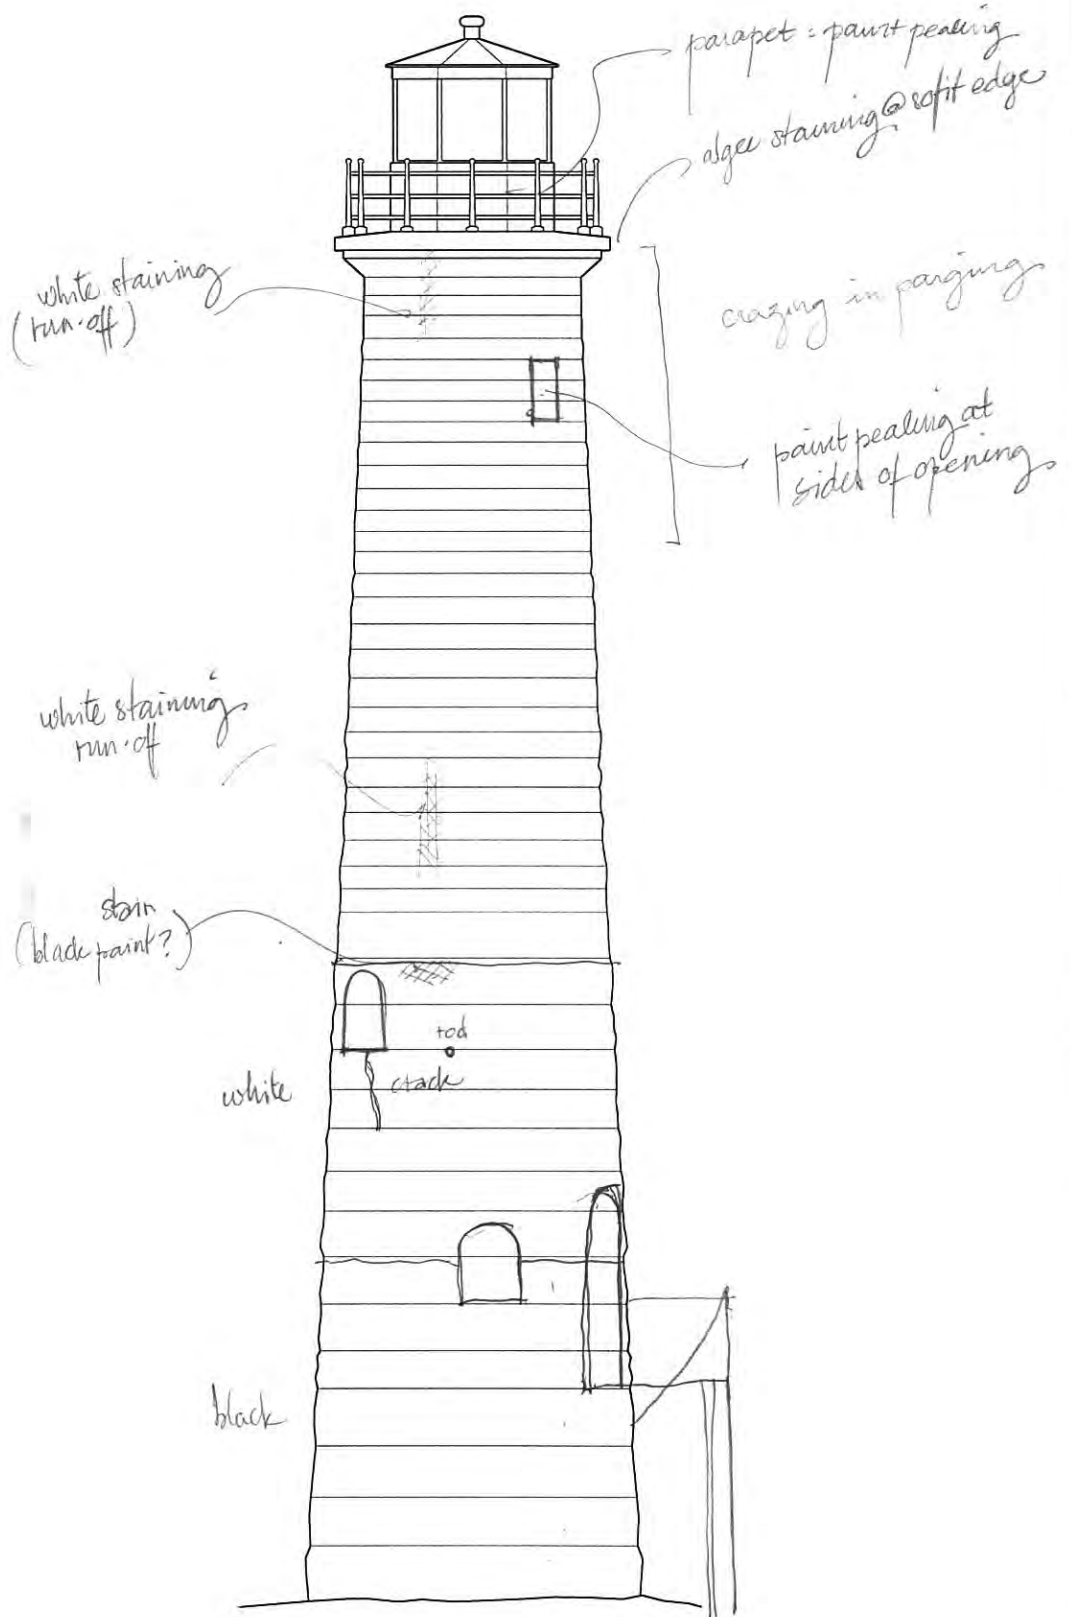
Elevation

interior damage to stone mostly concentrated on south side
