January 23, 2006

RE: Second Interim Report : Environmental Monitoring at Race Rocks Ecological Reserve related to the Pearson College – Encana - Clean Current Tidal Power Demonstration Project at Race Rocks

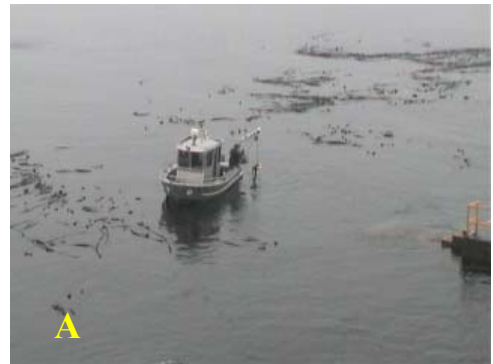
The SIMS survey was conducted October 6, 2005 over a 2hr period around the afternoon slack tide. Water depths ranged from 2mCD at the jetty (Photo A) to 19.8mCD at the turbine site. Boat tow speed was approximately 1knot, however the current did influence the speed at both ends of the slack window. Depth of the towfish above the seabed ranged between 0.5m and 1.5m (with the exception of the occasional entanglement with bull kelp) with most of the imagery collected at 1.0m above the bottom. The depth of the towfish (relative to CD) and trackline location data (UTM northing and easting, Zone 10) was burned on the imagery. Two copies of the SIMS imagery (burned on DVD) were provided to Pearson College.

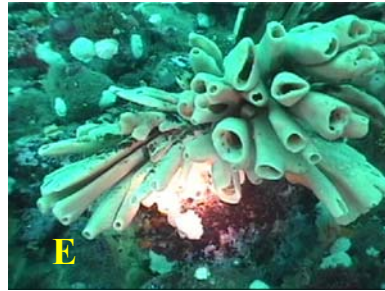
franciscanus, Photo B), anemones (*Metridium giganteum*, Photo C, brooding and other anemones, Photo D), demosponges (various encrusting and erect species including *Isodictya* sp., Photo E), hydroids (including erect and encrusting hydrocoral), and ascidians (including the lobed compound ascidian *Cystodytes lobatus*, Photo F). There are large urchin barrens at depths greater than 8mCD between the jetty and middle rocks. Fish species observed along the proposed cable route include kelp greenlings (both male and female), lingcod and rockfish (Quillback and copper) with kelp greenlings most abundantly noted.

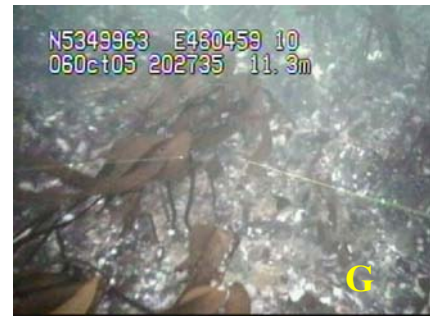
Generally, the substrate along the cable route between middle rock and the turbine site is dominated by gravel (cobble and boulder predominantly, limited shell hash and pebble) and bedrock/outcrops. More bedrock outcrops, with pockets of shell hash and fewer boulders on bedrock, characterize the cable route between middle rocks and the jetty. The predominantly hard bottom provides substrate for diverse marine vegetation, which includes the bladed kelps *Laminaria* spp., (*Laminaria saccharina/bondgardiana* in the shallow subtidal zone *Laminaria setchelli* >12m depth, Photo G), *Costaria costata* (dominant between 10-12mCD range), *Cymathere triplicata*, and *Pleurophycus gardneri*. *Pterygophora* (Photo H) and *Nereocystis* are the dominant canopy kelps at depths less than 9m in the vicinity of the jetty. Foliose and filamentous red alga is present at all depth ranges.

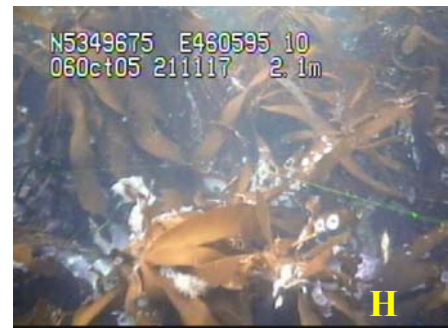
It is important to note that vegetation typically dies back in the winter months, usually between late October and February. As a result, identification of some species can be problematic (e.g. stipes only), and density or seabed cover will be less than during the spring and summer months. Seasonal variability becomes important when comparing pre and post construction video. Urchin grazing can also greatly affect vegetation density (creation of urchin “barrens” on one extreme) and often it is difficult to determine whether a short woody stipe is the result of urchin grazing or winter (perennial/annual growing cycle, storms) die back.

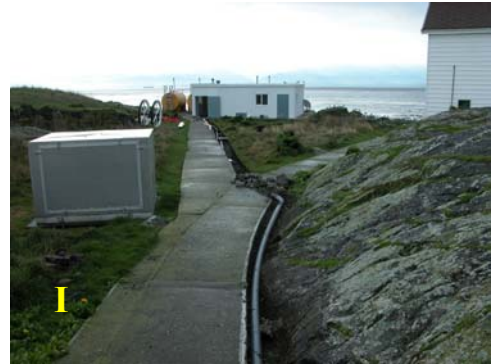
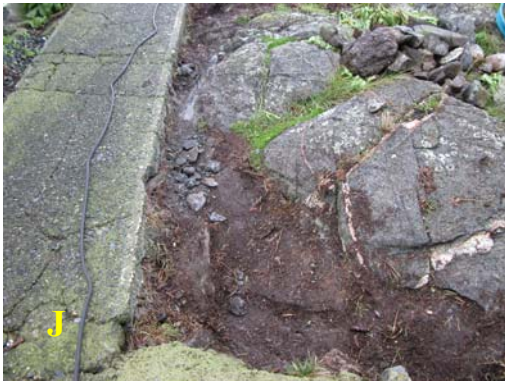
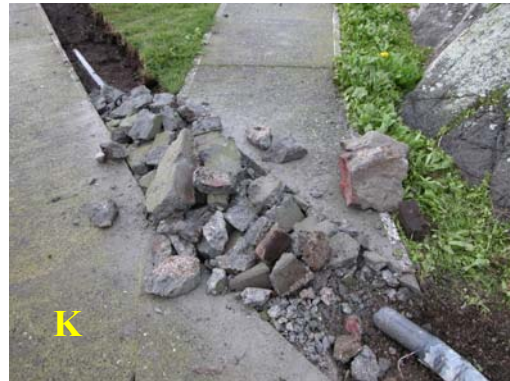
Although a large portion of the area along the sidewalk was fertile soil, it was anticipated that there would be a need to break up some concrete and bedrock immediately beside the sidewalk to accommodate the cables. Photo I shows the construction path immediately west of the sidewalk, while Photos J and K show close views of the bedrock and concrete demolition areas. Most of the concrete that was demolished alongside the sidewalk was placed back into the fill area while some will be hauled away with other constructions spoils.

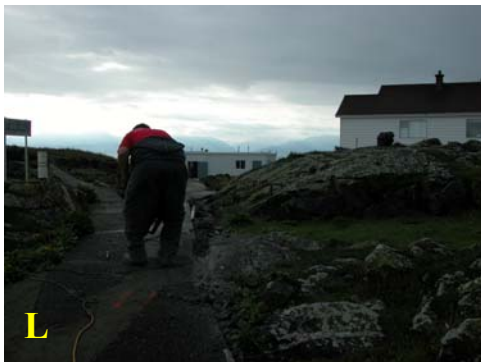
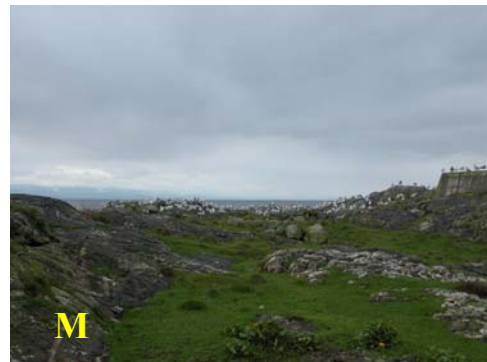
Observations on bird behaviour (gulls and cormorants) in the vicinity of the construction work were completed over a 45-minute period on November 8, 2005. Observations were made prior to, during (Photo L), and after jackhammer activity. There appeared to be little to no adverse effect on bird behaviour in that individuals and/or groups did not take flight immediately after work with the jackhammer started. Photo M shows both gulls and cormorants perched on the rock (immediately east of the construction area) during the onset of jackhammer use. A smaller, quieter and more mobile jackhammer than the one used for demolition work at the engine room, was employed.

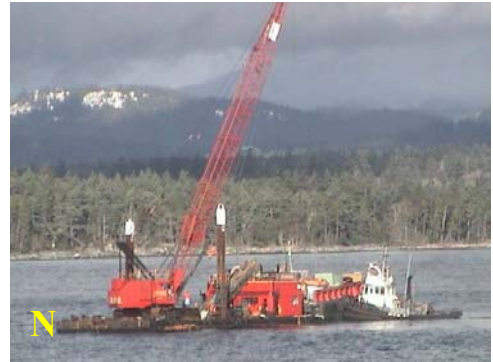
On November 29, 2005, the barge and drill rig were on site to start with the pile construction (Photo N). Planned monitoring activity included observations on i) marine mammal and bird behaviour, ii) construction equipment positioning and, iii) dispersion of the drill effluent plume. LGL's report on marine mammal and bird behaviour and disturbances at Race Rocks (Demarchi and Bentley 2004) was reviewed and the marine mammal observer (Rhonda Reidy, Archipelago) was prepped and ready to deploy.

Due to weather and associated safety concerns, a decision was made to postpone construction activity until January 2006.

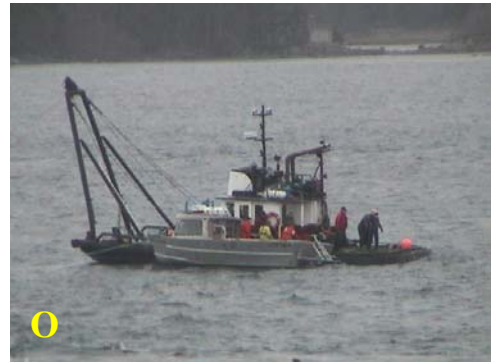
Between January 10 – 13, 2006, divers from Can-Pac, supported by Pearson College and a local tug (Blue Water Contracting, Photo O) attempted to install the drill template. Due to a thick layer of overburden material (<1m), the template was not successfully installed and the work crew left the site.

Drilling activity is planned to resume in the next few weeks. The drill company will proceed without the use of a diver positioned template. Direct contact with the drill operator needs to be made in order to review estimated volume of drill cutting escape given drilling will now occur through the boulder/cobble overlay. Further environmental monitoring will include i) marine mammal and effluent discharge observations during drilling and cable laying activity and, ii) a post construction dive inspection immediately following drilling activity (24 – 48 hours) in order to assess impacts.
