**Race Rocks Lighthouse**  
**Great Race Island, British Columbia**  
DFRP # 17447

**Condition Assessment**  
**Including Indicative Cost Estimate**

**Date:** December 14, 2007  
**HCD Project Number:** 115365  
**Team Leader:** Ève Wertheimer

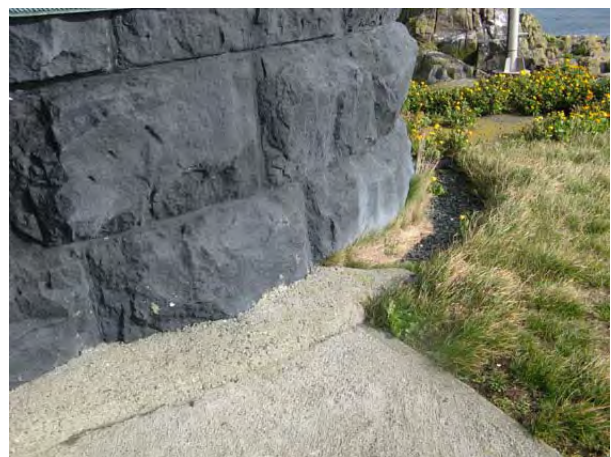
**Figure 15:** Asphalt surface abutting directly against the base of the tower. (HCN/2007)

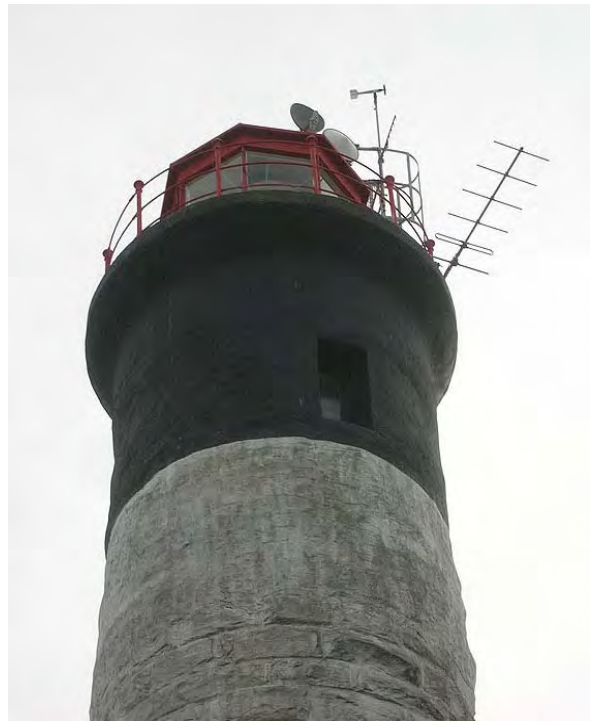
**Figure 17:** “Guniting” wall surfaces in the top third of the tower. (HCN/2007)

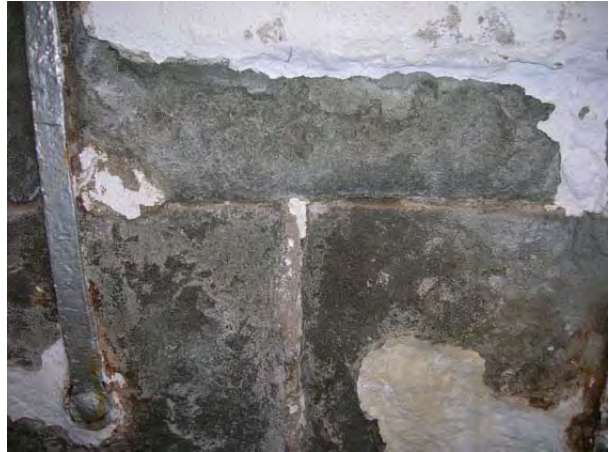
**Figure 21:** Delamination of the stone on the interior face of the top walls. (HCN/2007)

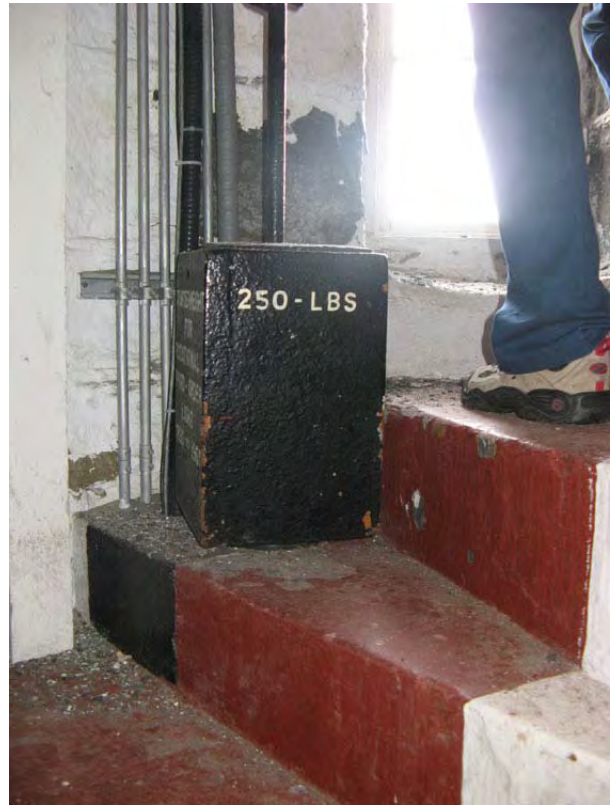
Overall, the interior stairs and floors were found to be in good condition. The stone stair has survived particularly well, testifying to the quality of materials and workmanship used in its construction. Minimal damage to the stone was in the staircase, and consisted mainly of limited delamination and salt deposits at the connection with severely affected wall portions, where there has no doubt been some moisture transfer. (*See Fig. 26*) Concerns are mostly related to Health and Safety, due to the important accumulation of debris on the treads from the adjacent deteriorating walls, and from the counterweight which is no longer in use and sits on the edge of one tread, at mid-height within the tower. (*See Fig. 27*)

**Figure 27:** The counterweight now rests at mid-height in the tower. (HCN/2007)

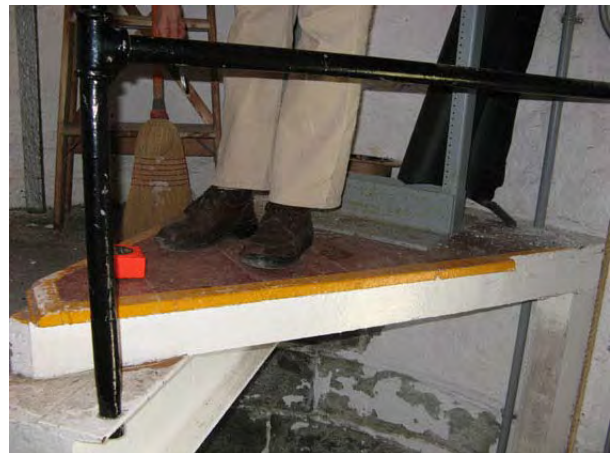
No evidence of deterioration was apparent at the first floor, which was level and without cracks. With the exception of the vertical cracks in the walls described previously, the underlying structure appears to be sound, and no sign of movement or settlement could be detected. The concrete landing at the top of the stair also appears sound, with no evidence of cracking on either its top or underside. The assembly of the wood platform, although somewhat clumsy in appearance, is also structurally sound. (*See Figs. 29 & 30*)

**Figure 29:** Concrete landing and wood platform at the top of the spiral stair. (HCN/2007)

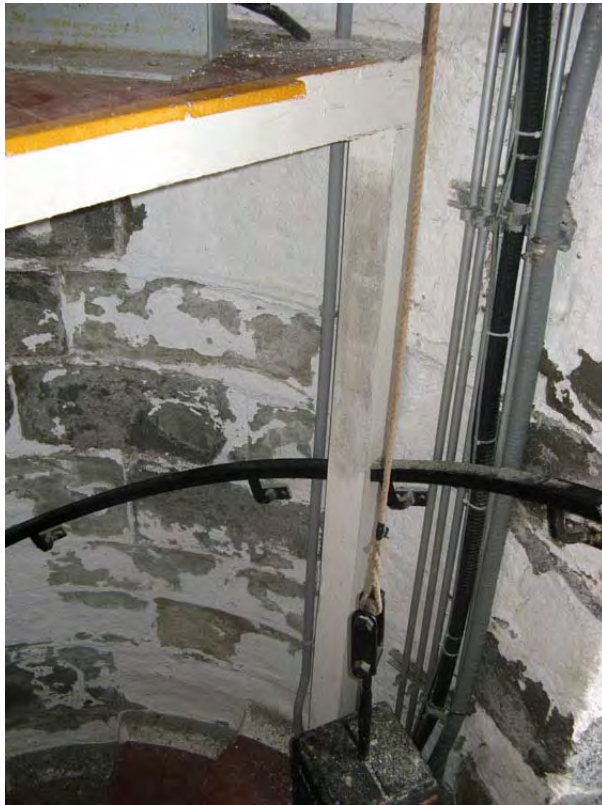
**Figure 30:** Post supporting the wood platform. (HCN/2007)

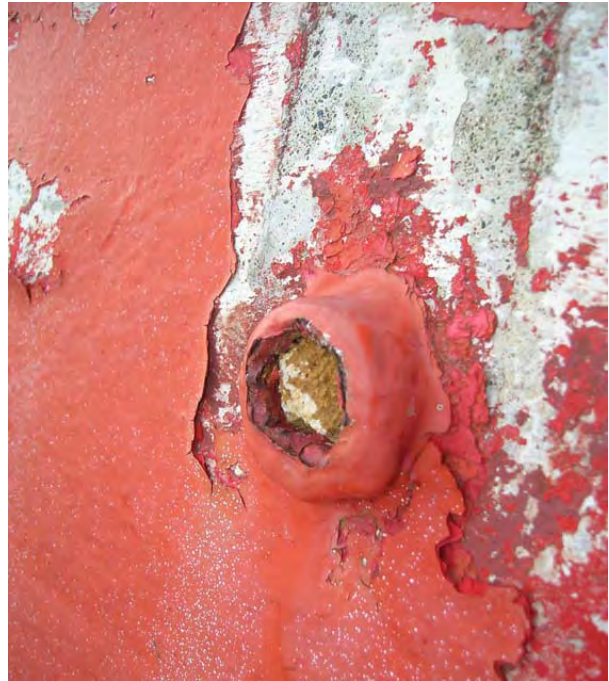
**Figure 41:** Plugged exterior condensation gutter drain. (HCN/2007)

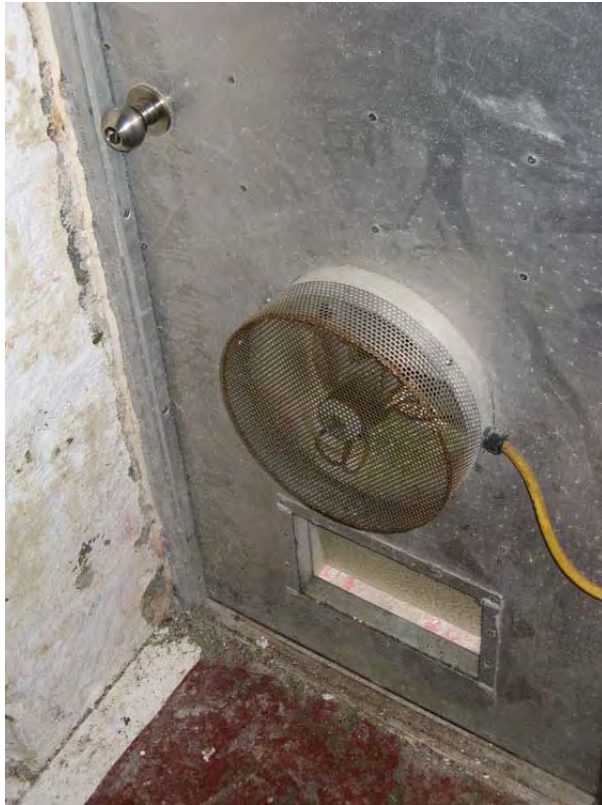
**Figure 48:** Ventilator set into the entrance door.  
(HCN/2007)

48. Provide additional active and passive ventilation, such as the installation of a ventilator in the door transom at the base of the tower, and of vents in the windows in the tower.
49. Reinstate a functioning heating system within the tower.

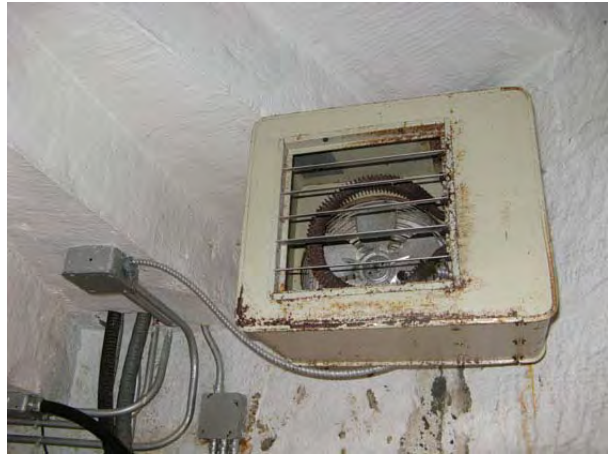
**Figure 49:** Electrical heater, now out of use.  
(HCN/2007)

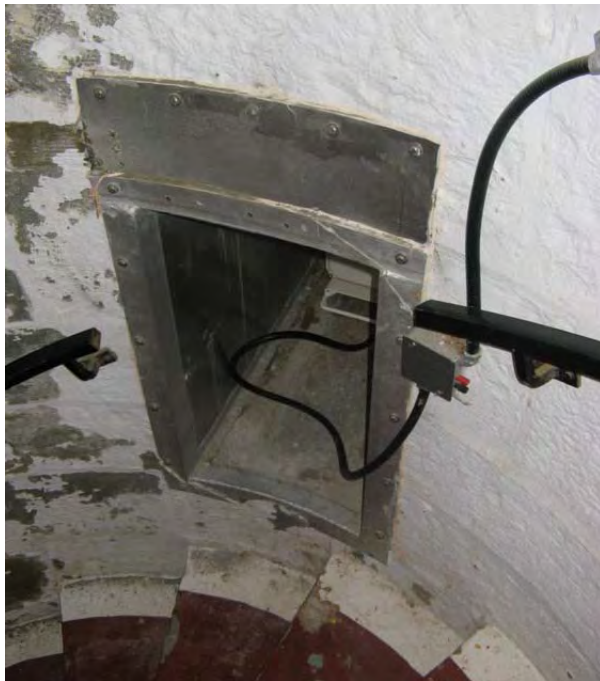
**Figure 52:** Interior side of the second opening from the top, fitted with the fog-detector. (HCN/2007)

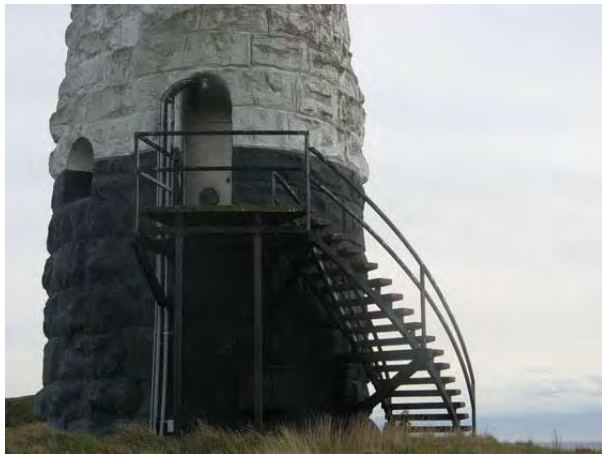
**Figure 56:** The exterior stair leading to the tower door. (HCN/2007)

59. Clean and repaint the exterior stair as required.
